# Operating Experience Weekly Summary 97-44

*October 24 through October 30, 1997*

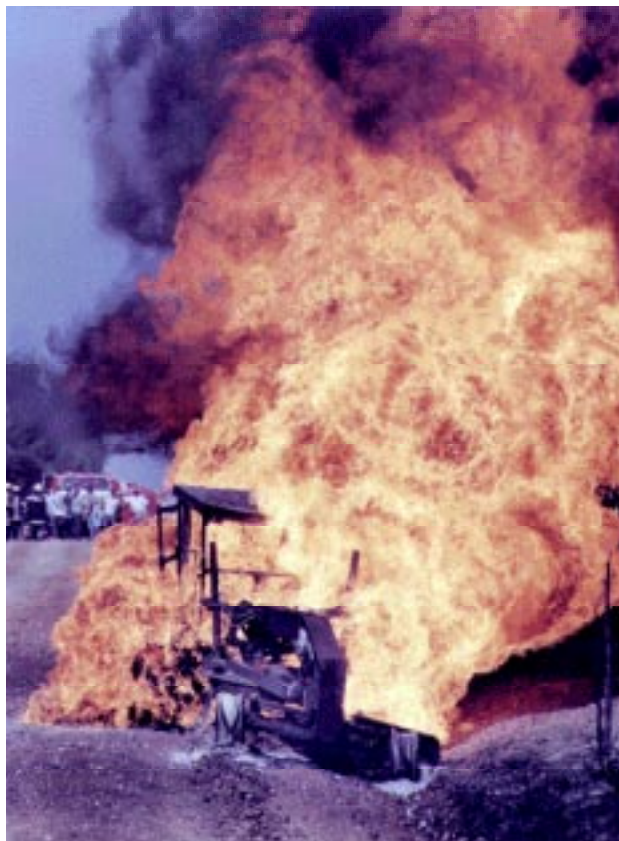
**Figure 6-1. Propane Line Severed<sup>1</sup>**

On October 27, 1997, a subcontractor at the National Institute for Petroleum and Energy Research ruptured a 2.5-inch natural gas utility line while digging a trench for an electrical installation. The facility manager ordered an immediate evacuation of the area and adjacent buildings. Facility personnel and the local fire department secured gas flow and isolated the line. Facility personnel are developing corrective actions, including requiring a walk-down of excavation areas before each job and implementing a dig permit program. Investigators reported that this is the third gas line ruptured during excavation activities this year. On July 14, personnel hit and ruptured a 1-inch natural gas line, at a 3-inch junction with a main line, during excavation work. On October 2, a contractor ruptured a 3-inch natural gas line while demolishing a building. Investigators determined that construction drawings did not show the correct location for the line. The facility manager directed investigators to perform a Type C investigation for the two most recent events because of the frequency of repeat occurrences. Figure 6-1 shows a 1989 event at Lebanon, Missouri, where an operator was killed when the road grader he was using struck a 10-inch propane pipeline.

These events underscore the importance of using effective work control practices and detailed pre-job planning. In the Hanford event, failure to lock or tag out the heat-tracing led to a worker being shocked. In the Idaho event, personnel reviewed drawings, performed line location surveys, and located the line before work began on the first phase of the project. However, failure to communicate and follow procedures endangered the backhoe operator during the second phase of the project. In the National Institute for Petroleum and Energy Research event there were indications that drawings were inaccurate and pre-construction walk-downs were not effective in preventing recurrences. Safety and health hazard analysis must be included in the work control process to help prevent worker injury. Pre-job briefings, facility procedures, and training programs should emphasize the dangers associated with excavation activities. Many events have occurred while personnel were digging, trenching, or drilling.
